44TH TURBOMACHINERY & 31ST PUMP SYMPOSIA
HOUSTON, TEXAS | SEPTEMBER 14 – 17 2015
GEORGE R. BROWN CONVENTION CENTER

CFD STUDY OF FAILURE IN AN OIL FLOODED SCREW COMPRESSOR JOURNAL BEARING

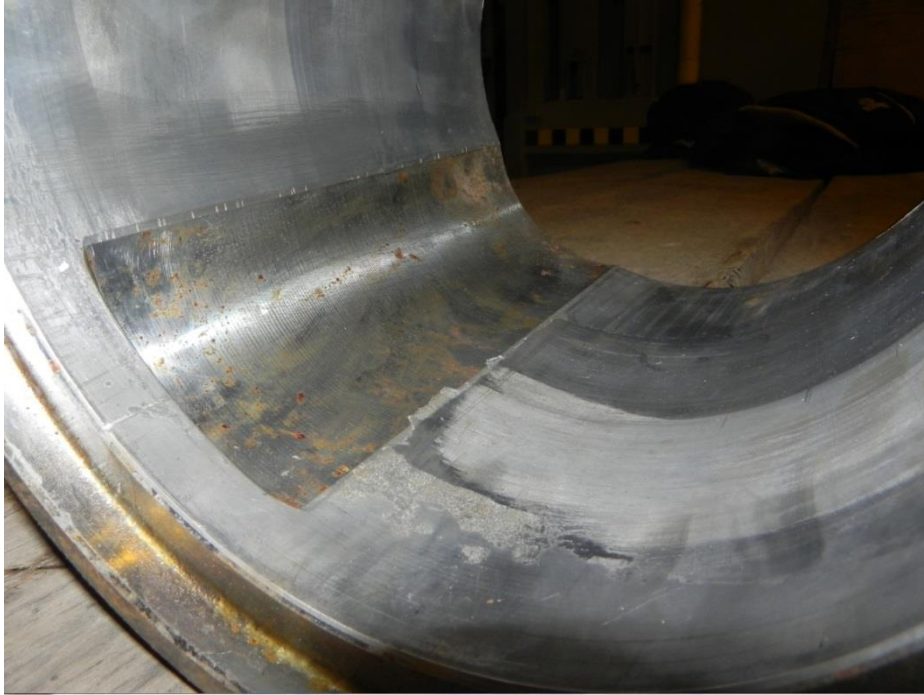
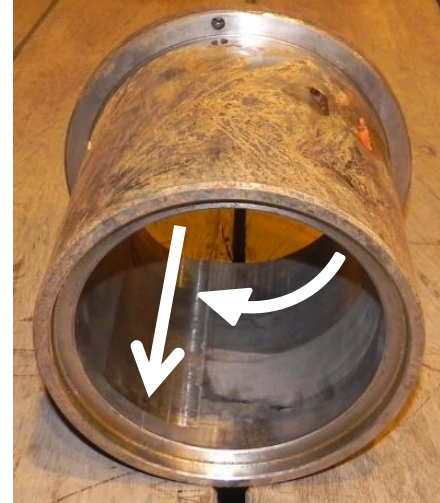
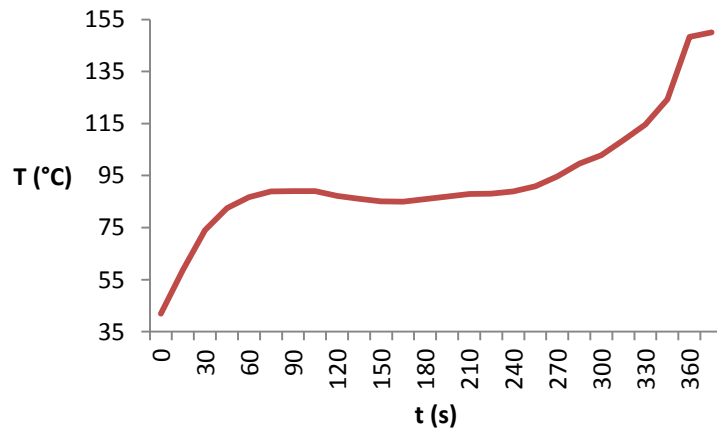
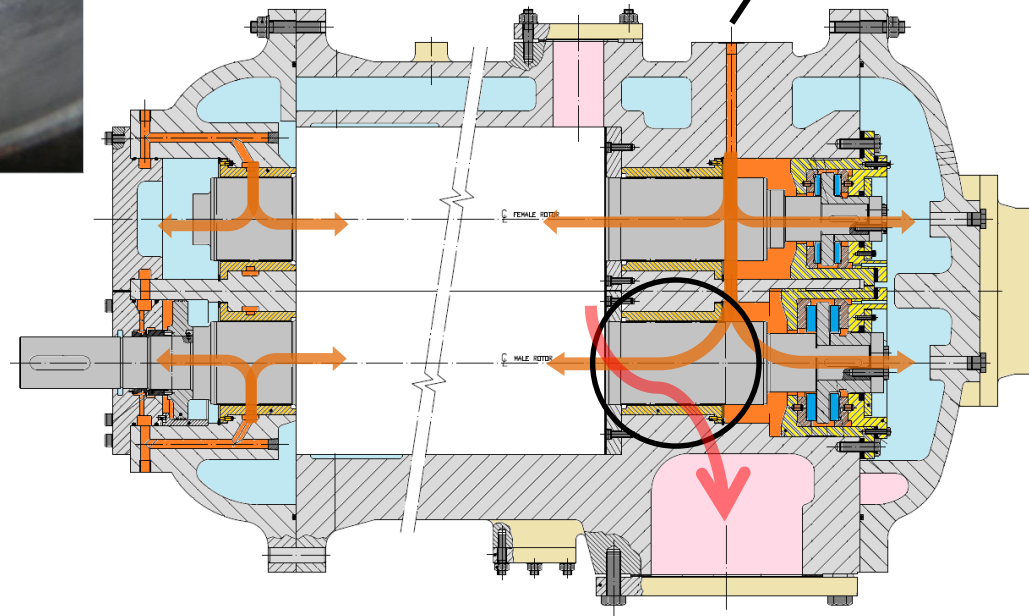
THE MACHINE

- Journal bearing failures (white metal melting) during commissioning of an new oil flooded screw compressor for vapor recovery service
- Only one bearing damaged (male NDE), but all journal bearings with high temperature
- Bearing without direct oil injection; located near the discharge; different from other bearings
- Trend analysis of available data was performed and some possible causes were identified

Oil flow
(orange path)

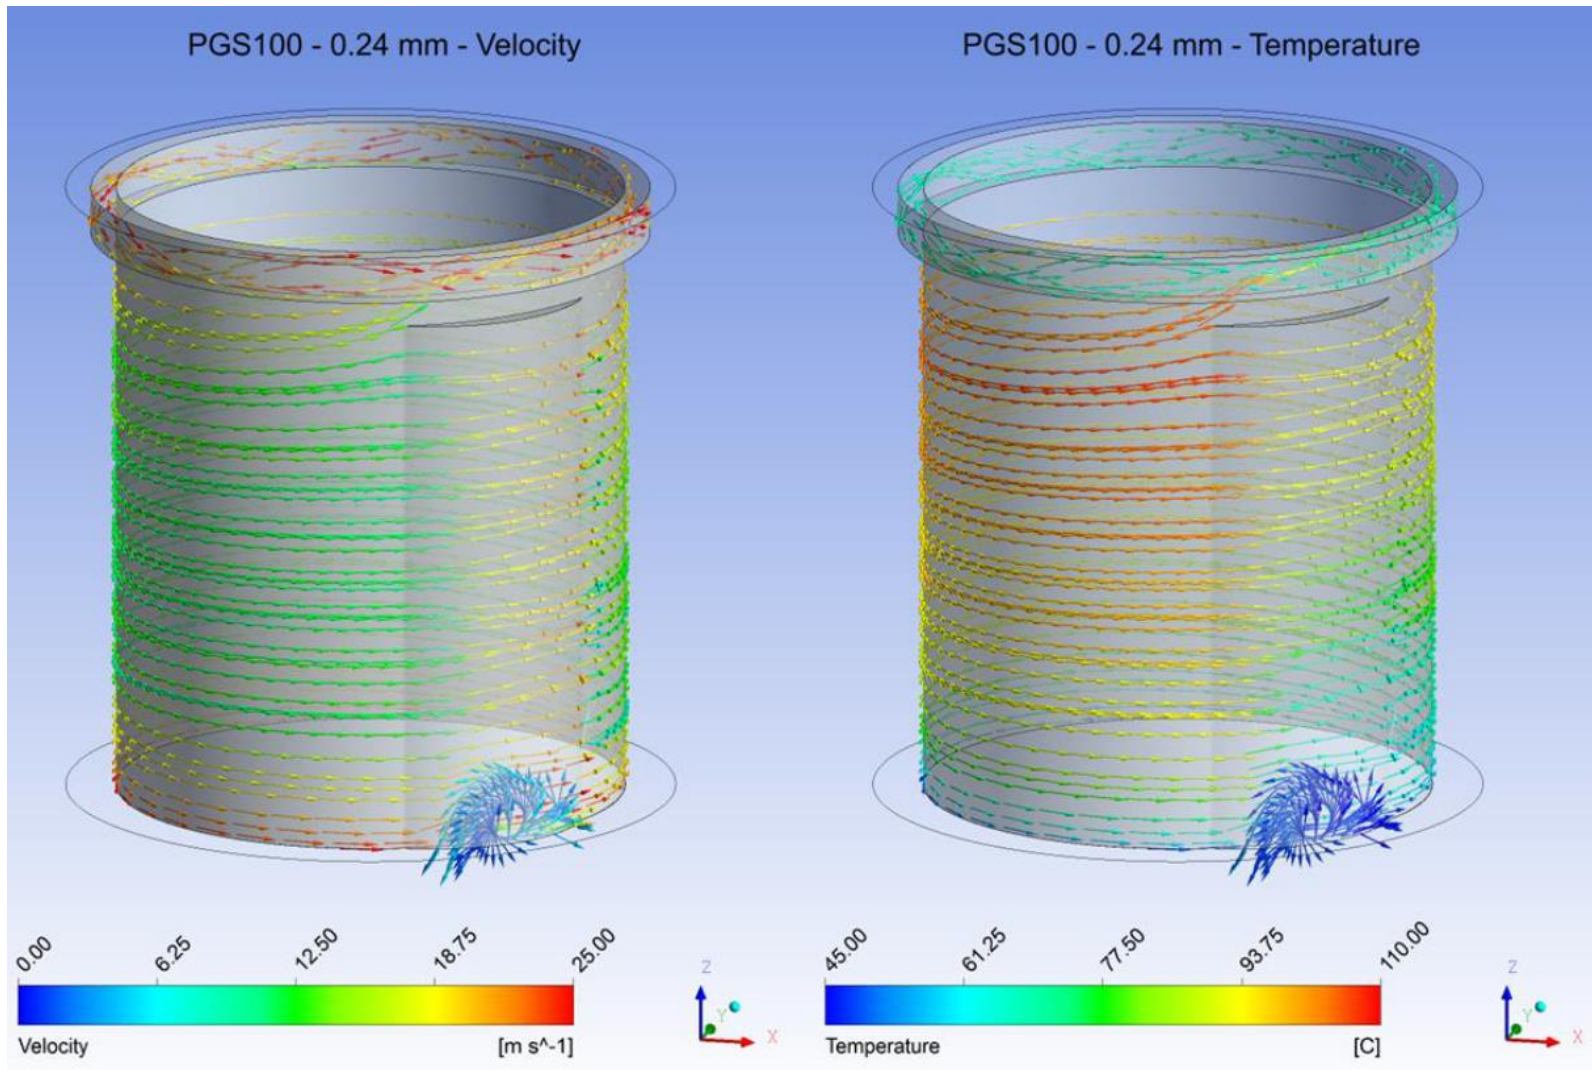
- Profiles after modifications:

- The proposed modifications were satisfactory, indicating that the main causes of bearing failures probably were **“low oil flow”** and **“wrong oil specification”**
- Test conditions for both installed and spare compressors were different from operational conditions (ISO VG68 oil and air running instead of Kluber PGS150 and process gas)
- Overcompression could have contributed to failures, but it was not confirmed
- Good agreement between field data and numerical results, indicating good boundary assumptions and suitable simplifications

- **Male NDE** clearance increase (0,19 to 0,24mm)
- Oil change (Kluber PGS 150 to PGS 100)
- Oil pressure increase (+2,5bar)
- Oil supply temperature reduction (50°C to 45°C)
- Individual oil injection to male NDE bearing
- Oil injection's logic modification to prevent an eventual oil pressure drop in the oil header
- Suction pressure reduction (1,80 to 1,35bara as designed)
